**CWA COMPLIANCE EVALUATION INSPECTION REPORT  
U.S. ENVIRONMENTAL PROTECTION AGENCY, REGION 5**

Compliance Evaluation Sampling Inspection

Sandway Farm, LLC  
E1411 Bolt Road  
Denmark, WI 54208  
44.341N, 87.699W

April 18, 2013

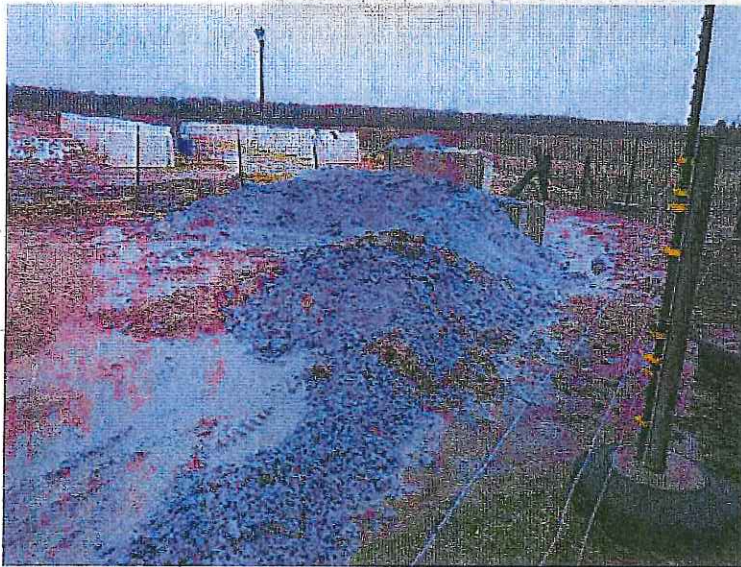
Location: North of Silage Bunkers

IMGP0050: Sandway utilizes a product made from pulverized newspaper as alternative bedding.

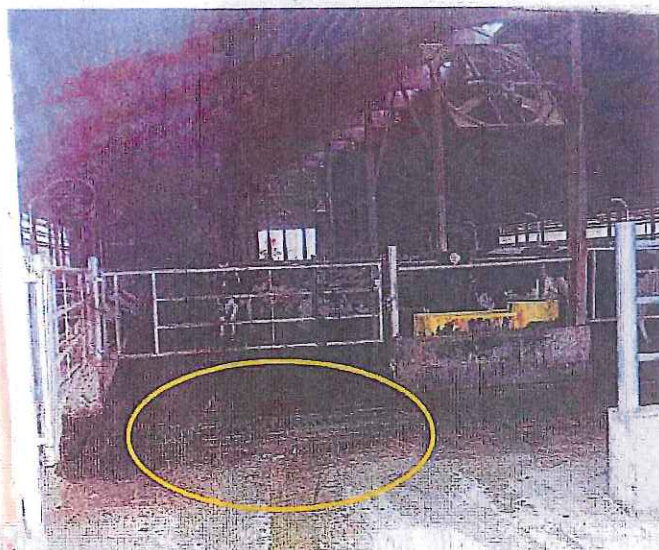
Location: South side of Barn #2

EPA also observed the collection channel for manure below the floor on the south side of Barn #2. Manure is scraped to a grate where it falls to the collection channel and then flows by gravity to a pit at the southeast corner of the barn. From here, the manure is pumped to the manure channel in the Main Barn.

IMGP0051: Inside Barn #2. Manure is manually scraped to grate in foreground where manure falls into a collection channel. The manure flows via gravity in the collection channel to a pit in the southeast corner of the barn. Yellow circle denotes location of the grate in the floor where manure is pushed into.

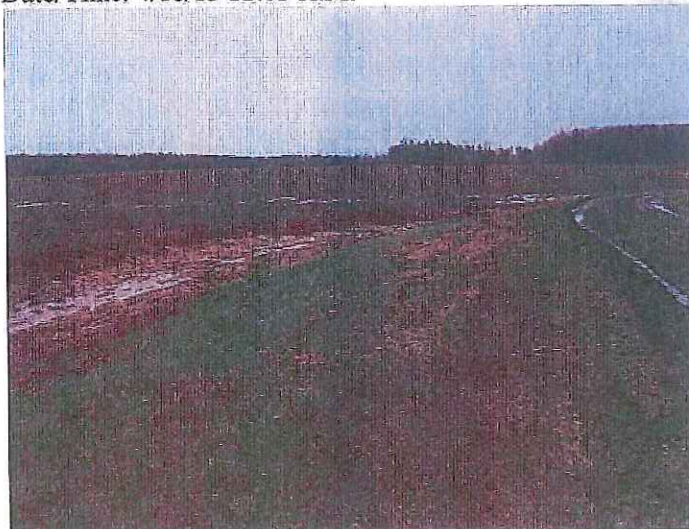
Location: East of 2<sup>nd</sup> Stage Manure Holding Pond

IMGP0087: East Ditch flows south on the east side of the facility.

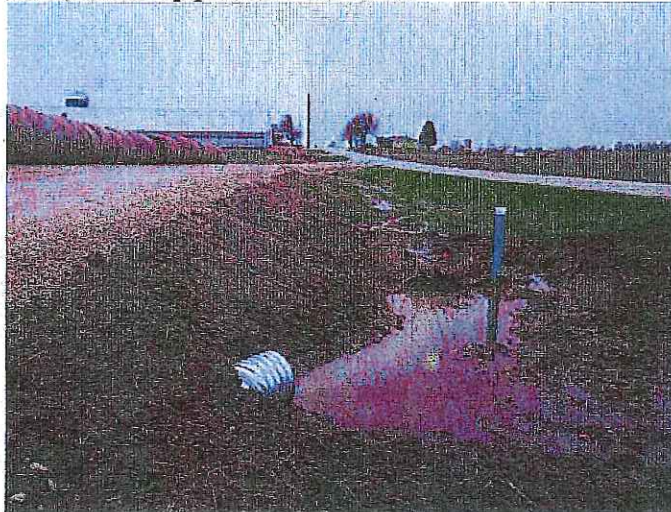
Location: Along Bolt Road and north of the 2<sup>nd</sup> Stage Manure Holding Pond

At the northeast corner of the facility, a culvert directed flow from a roadside ditch to the East Ditch. The culvert went under a facility driveway. Storm water also flows to the East Ditch via a pipe under Bolt Road from the north. A green standpipe indicated the location of the pipe under Bolt Road.

IMGP0089: Culvert accepts flow from the roadside ditch and directs it to the East Ditch that flows to the south along the east side of the facility. Green standpipe indicates location of pipe under Bolt Road.

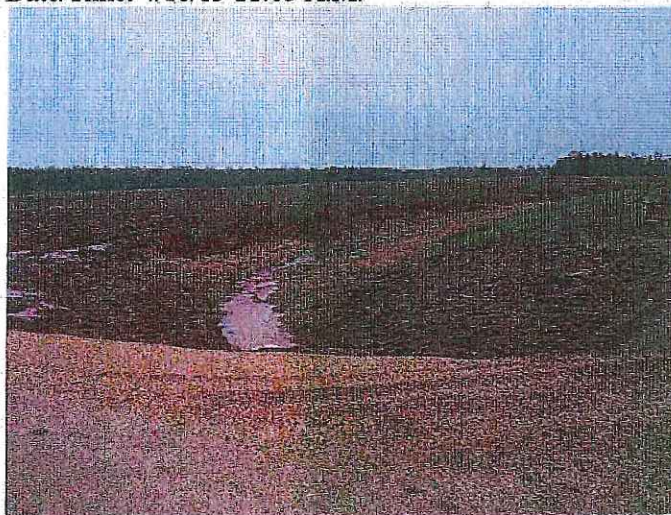
Location: Along Bolt Road and north of the 2<sup>nd</sup> Stage Manure Holding Pond

IMGP0090: Outlet of the culvert from roadside ditch flows under facility driveway. Flow goes to the south in the East Ditch.

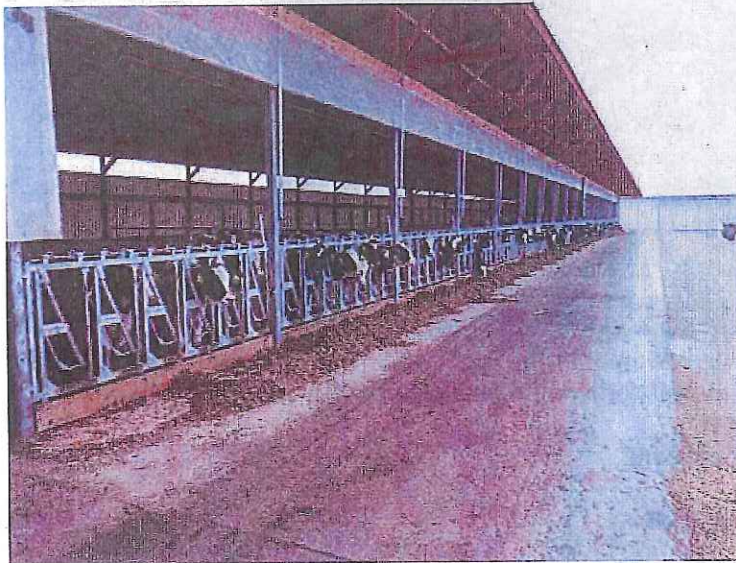
EPA walked east along the south side of the new Calf Barn which houses 136 calves. The roof overhangs the feed lane to prevent feed runoff. There are no gutters on the Calf Barn roof. Raw materials were stored in the west end of the barn and the load in door was on the east side. EPA did not observe any problems or issues with the Calf Barn on the day of the inspection.

IMGP0092: The new Calf Barn holds 136 calves.  
Location: East of the 2<sup>nd</sup> Stage Manure Holding Pond  
Facing: Northeast  
Date/Time: 4/18/13 11:07 A.M.

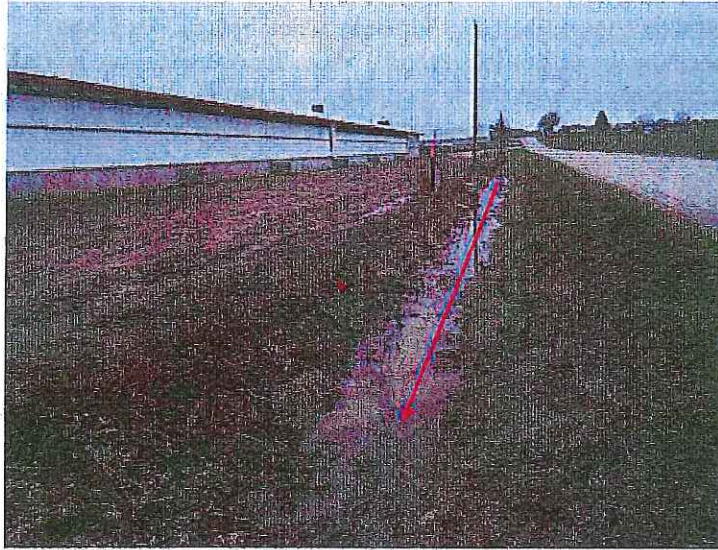
Location: North of the Calf Barn

EPA walked west on the north side of the Calf Barn. The area north of the barn had not been seeded with vegetation yet. The roadside ditch flowed from west to east in front of the barn. There was water in the roadside ditch all the way to the Main Barn.

IMGP0096: Roadside ditch along Bolt Road and north of the Calf Barn. Vegetation hasn't been established in yard north of the barn yet. Flow in culvert is to the west, as indicated by the red arrow.

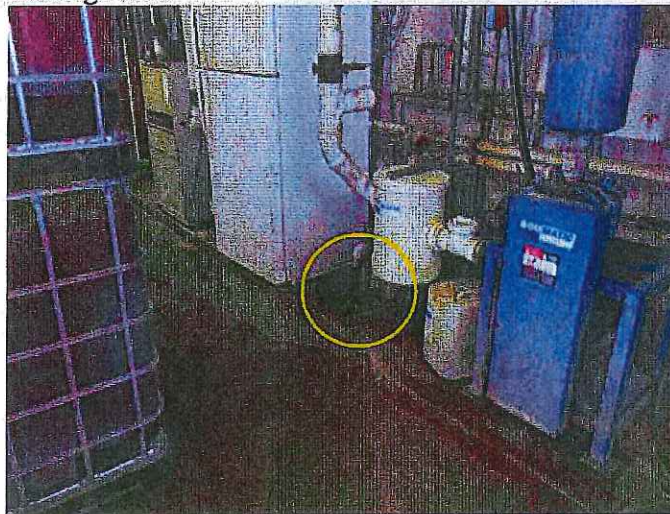
Location: South side of the Milking Parlor

Milking Parlor wash water flows to a sump from where it is then pumped to the manure channel in the Main Barn. From there, it flows with the manure to the 1<sup>st</sup> Stage Manure Holding Pond.

IMGP0112: Inside the back of the Milking Parlor. Sump, next to refrigerator (circled with yellow circle), receives flow from Milking Parlor wash water.

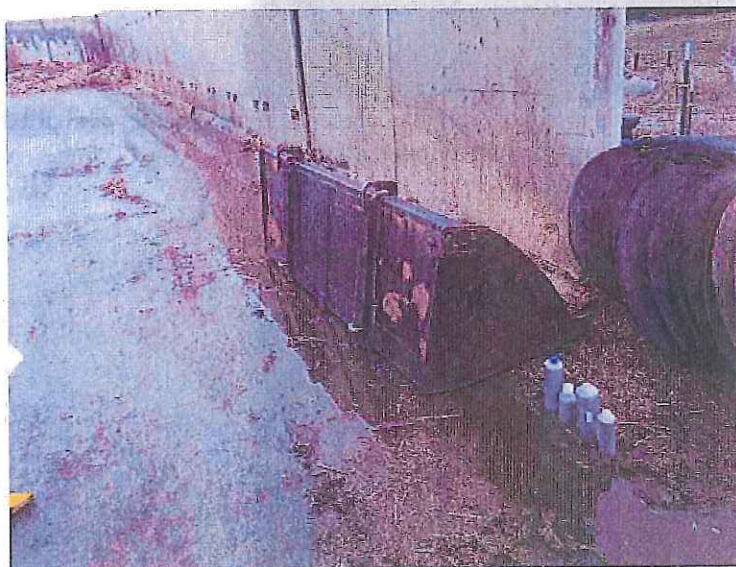
Location: Entrance to the southernmost feed bunker

EPA prepared sample bottles then returned to take samples at Sandway and observe the confluences of the East Ditch and West Ditch with the perennial unnamed tributary. EPA took the first sample, S01, titled "Bunker", at 1:20 P.M. from the flow of leachate from the manure pile in the southernmost feed bunker. While EPA was preparing the bottles, the precipitation that had been occurring during the walk through of the facility had diminished. Also, Exemption 6 had deposited a pile of straw in the flow pathway from the manure pile. There was a flow of process wastewater from the manure pile.

IMGP0121: Sample #1, S01, "Bunker", was taken at 1:20 P.M. from the flow pathway from the manure that was stored in the feed bunker.

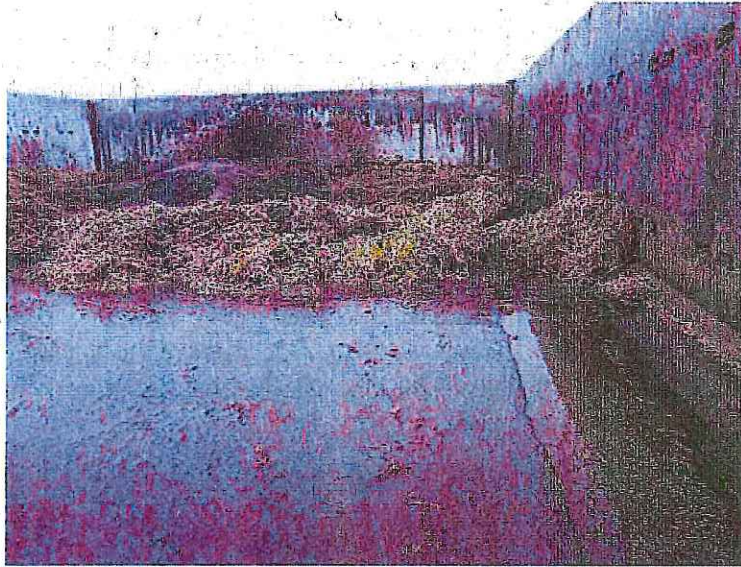
IMGP0122: By the time sampling started, the rain had ceased and some straw in the flow pathway from the manure in the bunker. Exemption 6 had piled  
 Location: Inside the southernmost feed bunker  
 Facing: Southeast  
 Date/Time: 4/18/13 1:22 P.M.

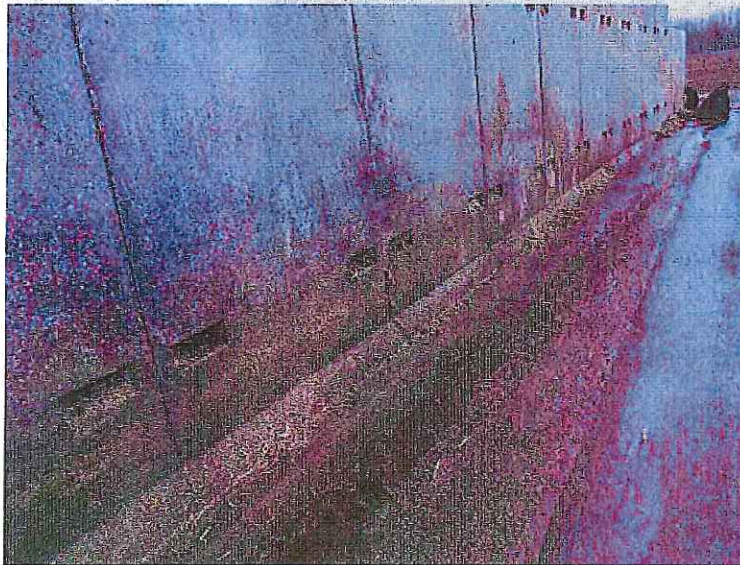
IMGP0123: Flow pathway off the manure stored in the feed bunker.  
 Location: Inside the southernmost feed bunker  
 Facing: West  
 Date/Time: 4/18/13 1:22 P.M.

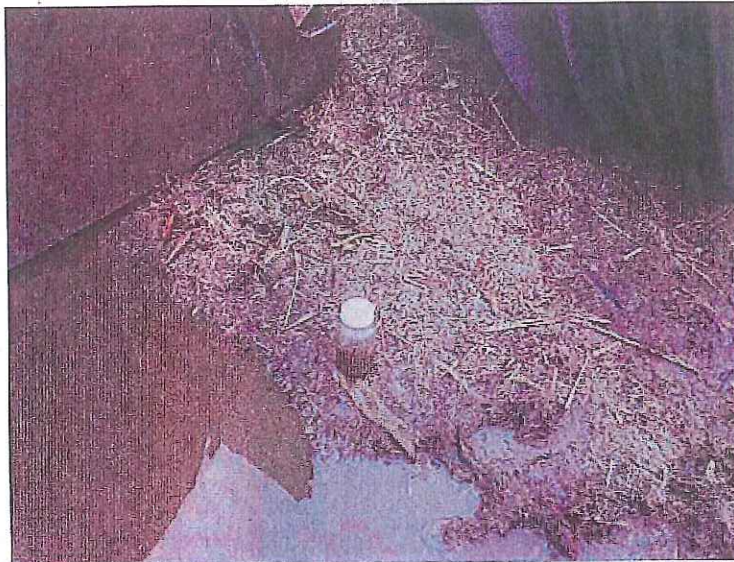
IMGP0124: Fecal coliform sample S01 "Bunker" was taken at 1:20 P.M. from flow pathway off the manure stored in the feed bunker.

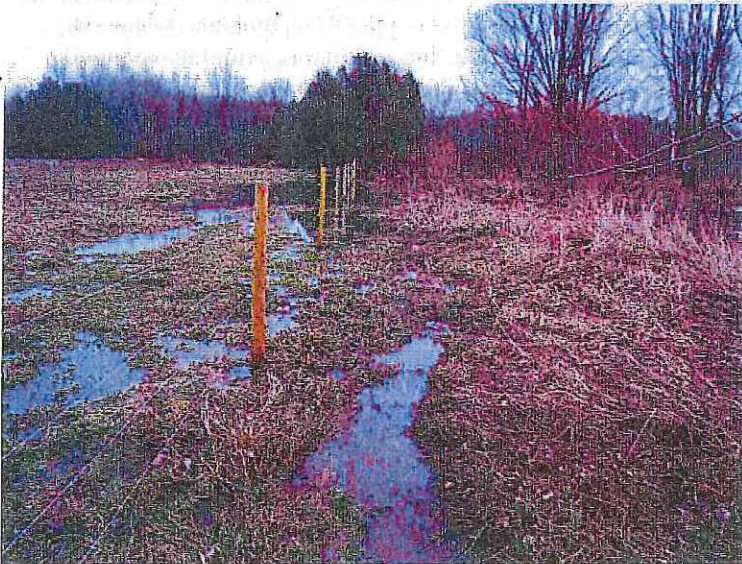
Location: West side of Pasture #1

IMGP0131: West Ditch pools in the pathway.

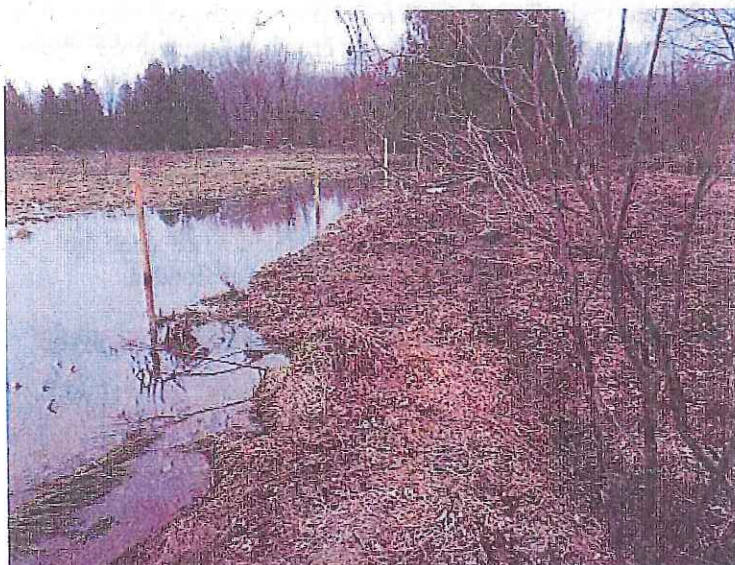
IMGP0134: West Ditch before the confluence with the perennial unnamed tributary.  
 Perennial unnamed tributary is in the tree line.  
 Location: West side of Pasture #1  
 Facing: Southeast  
 Date/Time: 4/18/13 1:28 P.M.

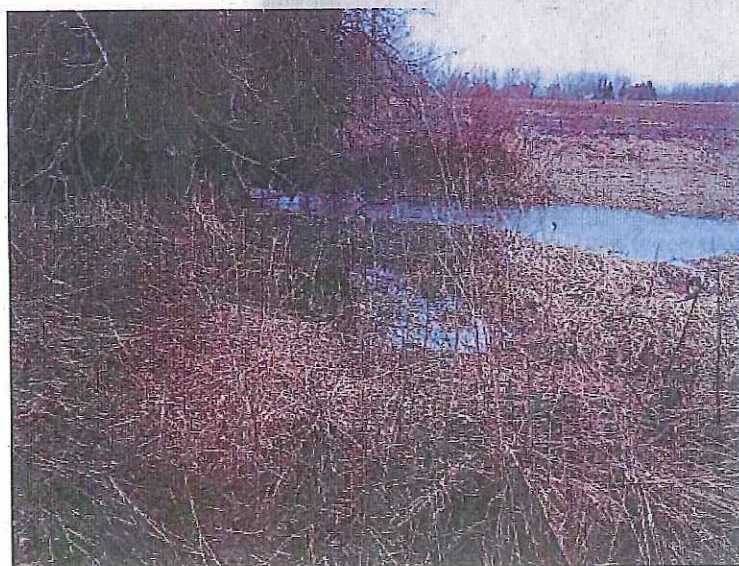
IMGP0138: Confluence of the West Ditch with the perennial unnamed tributary.  
 Location: Southwest corner of Pasture #1  
 Facing: South  
 Date/Time: 4/18/13 1:32 P.M.

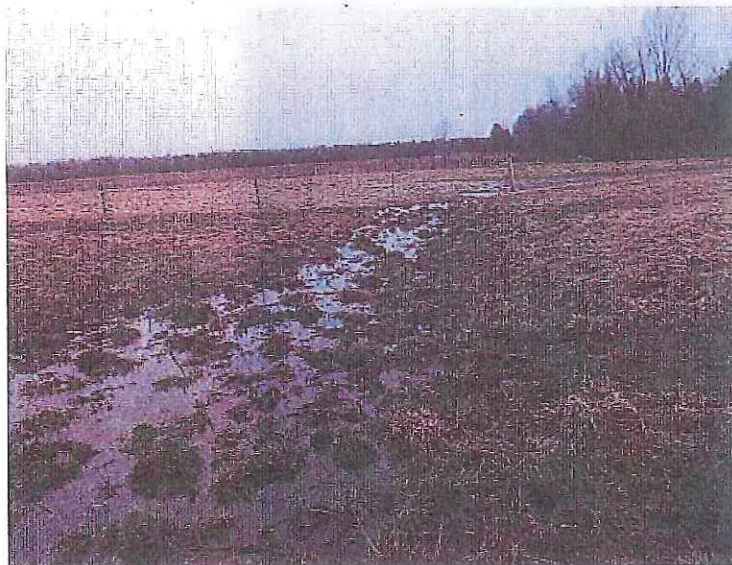
**Location: Pasture #1**

Some of the precipitation flow through piles of waste feed on the southwest corner of the production area would flow into Pasture #1. The flow was broad and went to the south before turning to the east approximately halfway into the pasture. The flow was generally channelized through the pasture and crossed into Pasture #2 and then turned south again. At the southern end of Pasture #2, the flow formed a large pool of water. It spread all the way to the east side of Pasture #2 where the East Ditch flowed south just outside the fence line of Pasture #2. The actual confluence of the flow through Pasture #2 and the East Ditch with the perennial unnamed tributary was undefined since the perennial unnamed tributary had left its banks and the whole area was flooded.

**IMGP0145: The water pathway takes an easterly course through Pasture #1.**

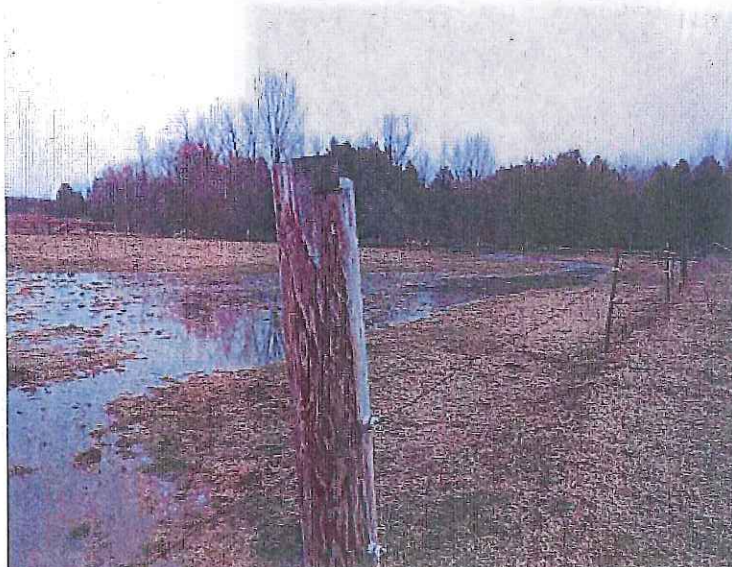
**Location: East side of Pasture #1**

**IMGP0147: The flow pathway leaves Pasture #1 and enters Pasture #2.**

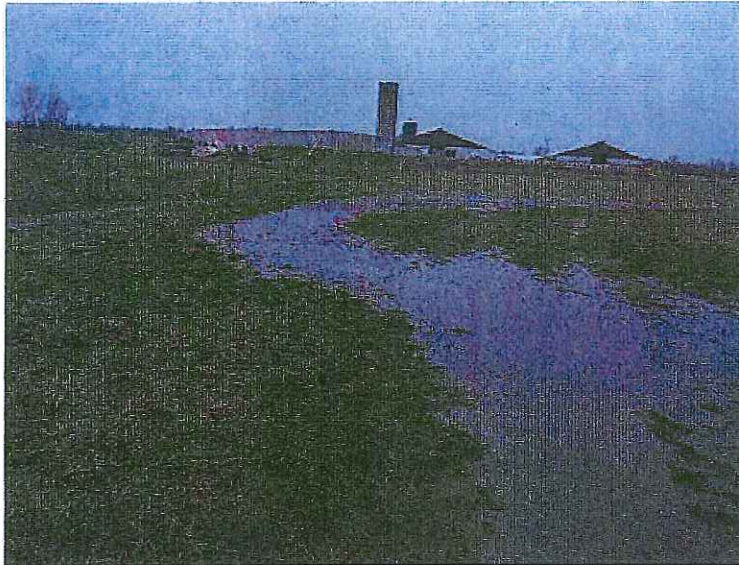
Location: Pasture #2

IMGP0149: Once in Pasture #2, the flow turns to the south.

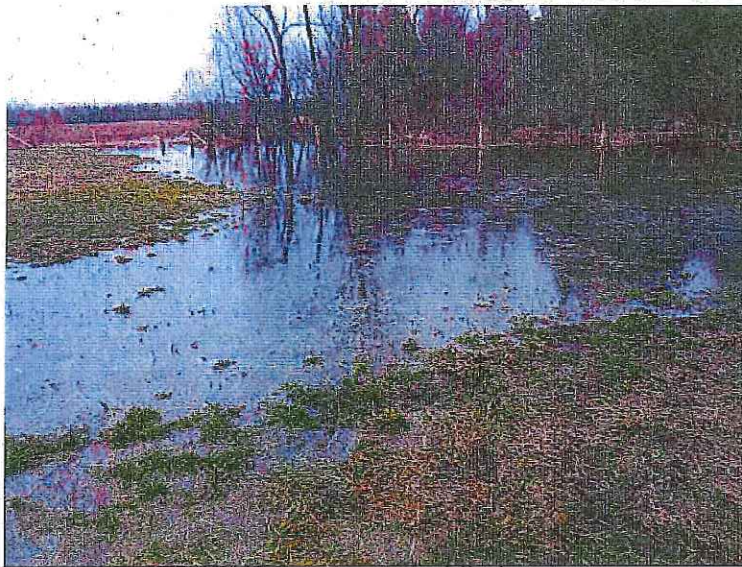
Location: Southern end of Pasture #2

IMGP0150: Just north of the confluence of the flow pathway in Pasture #2 and the perennial unnamed tributary.

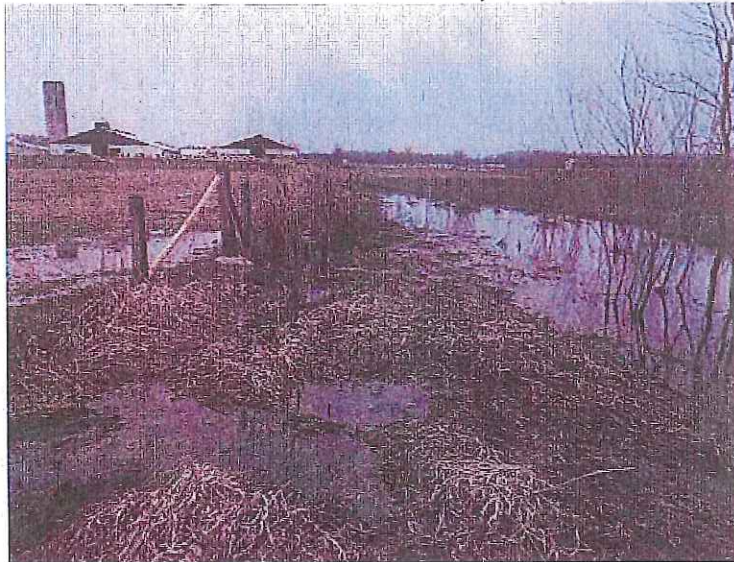
Location: Southern end of Pasture #2

IMGP0151: Flow pathway from Pasture #2 is on the left side of the photo. On the right side is the East Ditch.

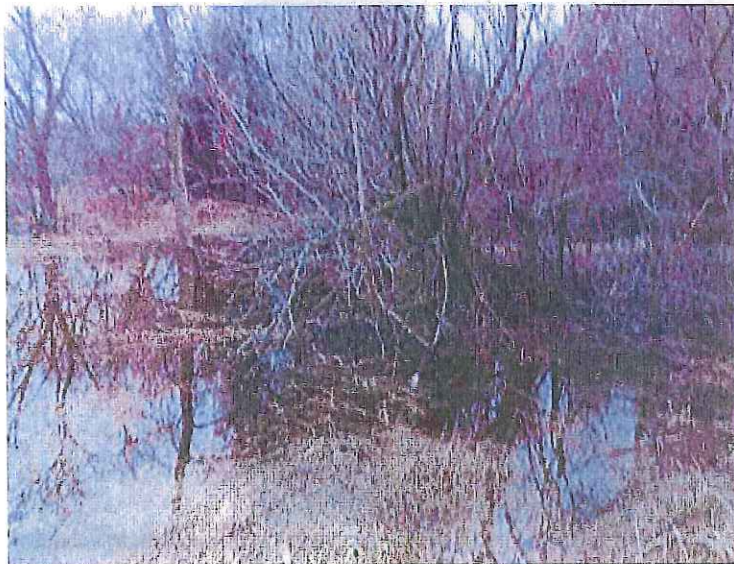
Location: Southern end of Pasture #2

IMGP0152: Confluence of flow pathways with perennial unnamed tributary.

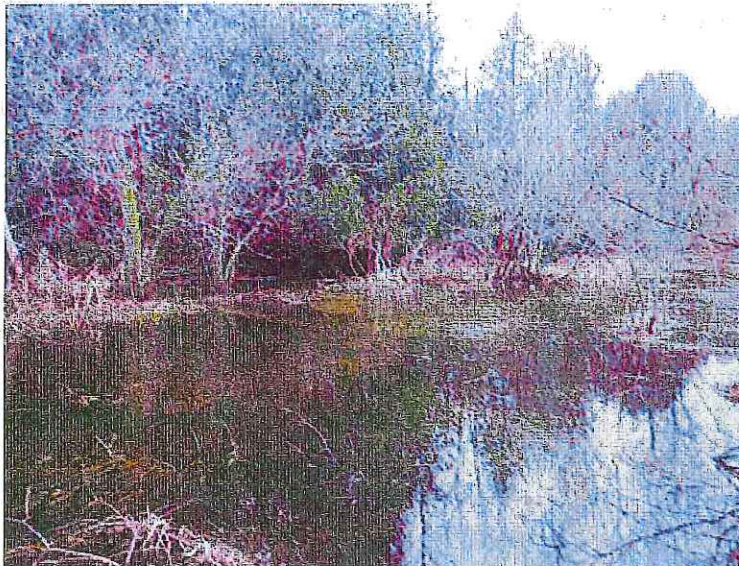
Location: Southern end of Pastures #2 and #3

IMGP0156: The regular channel of the perennial unnamed tributary is in the tree line.

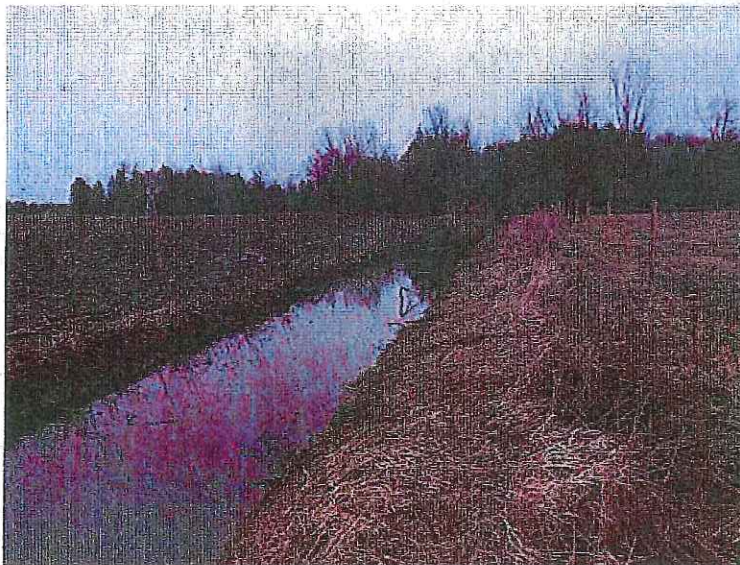
Location: East side of Pasture #2

IMGP0158: East Ditch is well defined on the east side of Pasture #2. Fence delineates the eastern edge of Pasture #2.

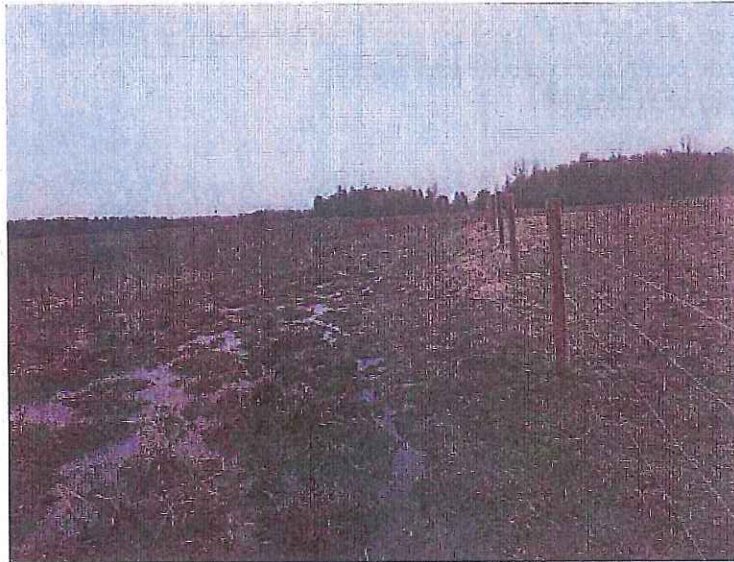
Location: Northeast corner of Pasture #3

IMGP0168: Looking downstream at the East Ditch as it flows south along the east side of Pasture #3.

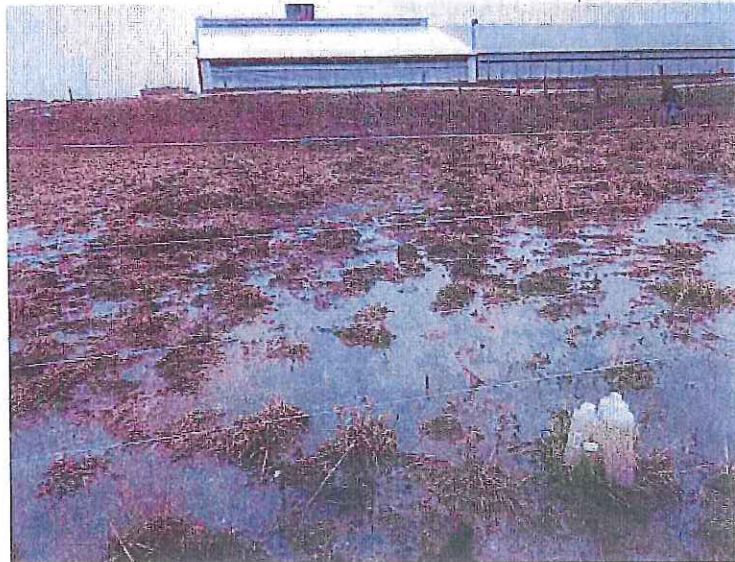
Location: Northeast corner of Pasture #3

At the northeast corner of Pasture #3, EPA observed the flow pathways coming from the white pipes in the hillside in the northwest corner of Pasture #3. EPA took sample number S02, named "Pipe Area", at 1:52 P.M. from the pool of water at the east fence line of Pasture #3 where the flow from the pipes that discharge flow into Pasture #3 would confluence with the East Ditch.

IMGP0170: Sample number S02, "Pipe Area", was taken at 1:52 P.M. from the pool of water at the east fence line of Pasture #3 where the flow from the pipes that discharge flow into Pasture #3 would confluence with the East Ditch.

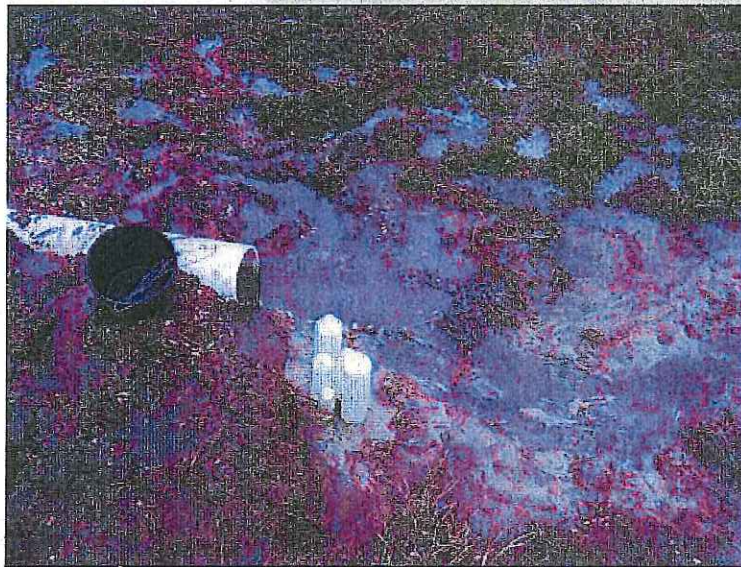
Location: Pipe outlet in Pasture #3

EPA went to the pipe outlets and observed that one of the pipes had liquid flowing from it. EPA took sample S03, named "North Pipe", at 2:03 P.M. from the northernmost pipe of the two pipes that discharge flow to Pasture #3.

IMGP0171: Sample S03, "North Pipe", was taken at 2:03 P.M. from the northernmost pipe of the two pipes that discharge flow to Pasture #3.

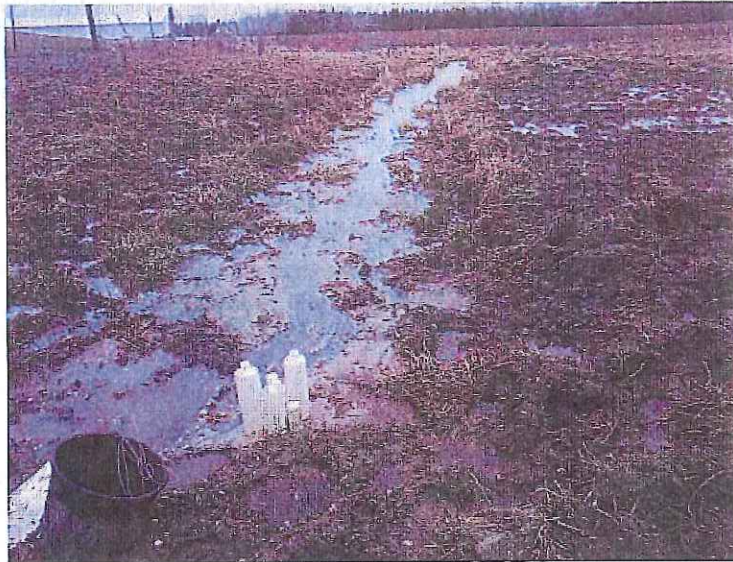
Location: Pipe outlet in Pasture #3

IMGP0172: Sample S03, "North Pipe", was taken at 2:03 P.M. from the flow from the northernmost pipe of the two pipes that discharge flow to Pasture #3.
